Manhole Inspection Summary

Manhole # S21K1_014MH

Insp Date: **4/24/08 9:41 AM**

Location Address: **2621 stranden rd**

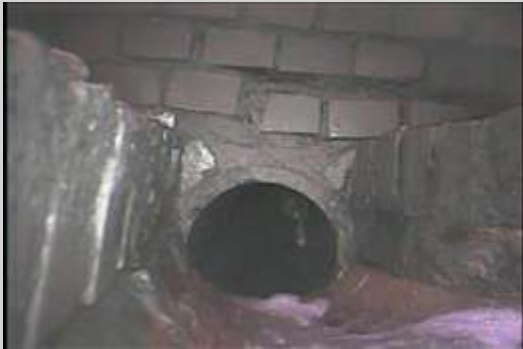
12 O'Clock Outflow

8 in. Circular Gravity Sewer
Pipe Out @ 12 O'Clock

Pipe Height: **8.4** (in.) Rod and Bar (Angled)
Pipe Material: **Clay** ☐ Pipe Lined
Invert Depth: **11.70** (ft.) Flow Characteristics: **Slow**
Deposits: ☒ None ☐ Mud ☐ Gravy ☐ Debris ☐ Grease
Silt Depth: **0** (in.) Deposits Extent:
Infiltration: **None** Pipe Seal Cond: **Sound**

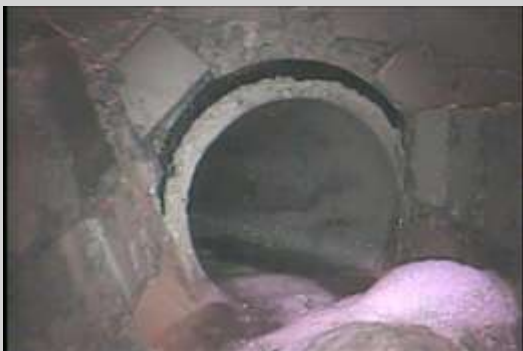
3 O'Clock Inflow

8 in. Circular Gravity Sewer
Pipe In @ 3 O'Clock

Pipe Height: **8.4** (in.) Rod and Bar (Angled)
Pipe Material: **Clay** ☐ Pipe Lined
Invert Depth: **11.14** (ft.) Flow Characteristics: **Slow**
Deposits: ☒ None ☐ Mud ☐ Gravy ☐ Debris ☐ Grease
Silt Depth: **0** (in.) Deposits Extent:
Infiltration: **None** Pipe Seal Cond: **Sound**
